Monitoring Completed Navigation Projects (MCNP) Program

Montgomery Point Lock and Dam, White River, Arkansas

Allen Hammack, Michael Winkler, and Howard Park

January 2016

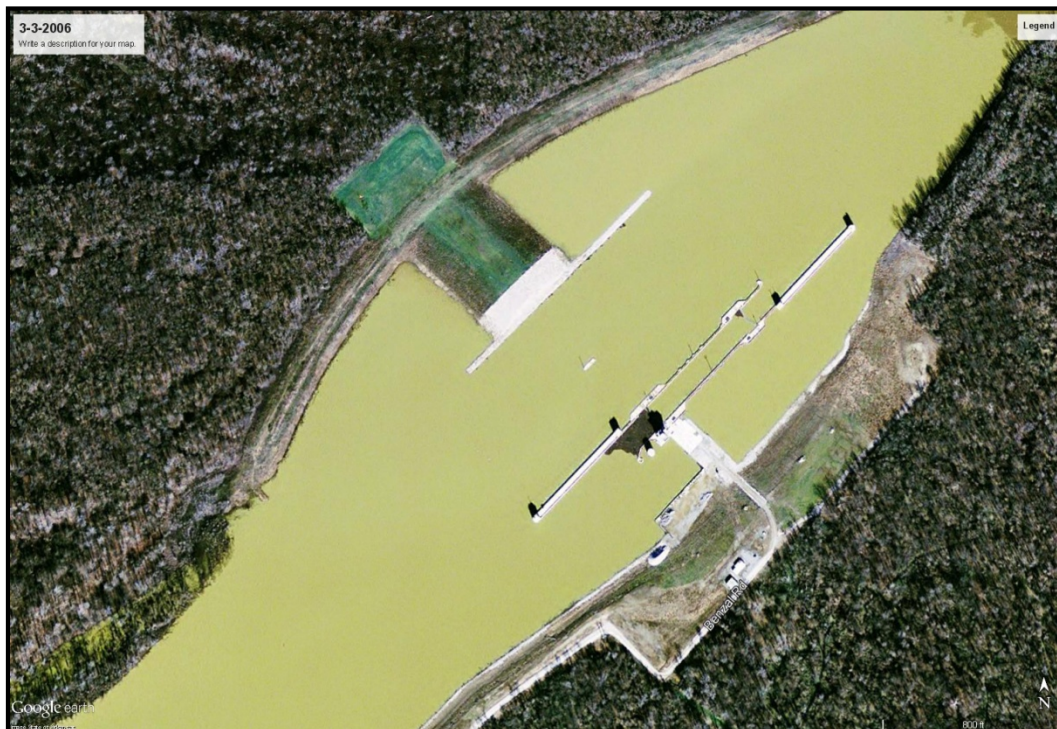
Figure 8. MPLD at higher water, 3 March 2006. Note spur dike and most of revetments are under water (photo from Google Earth).

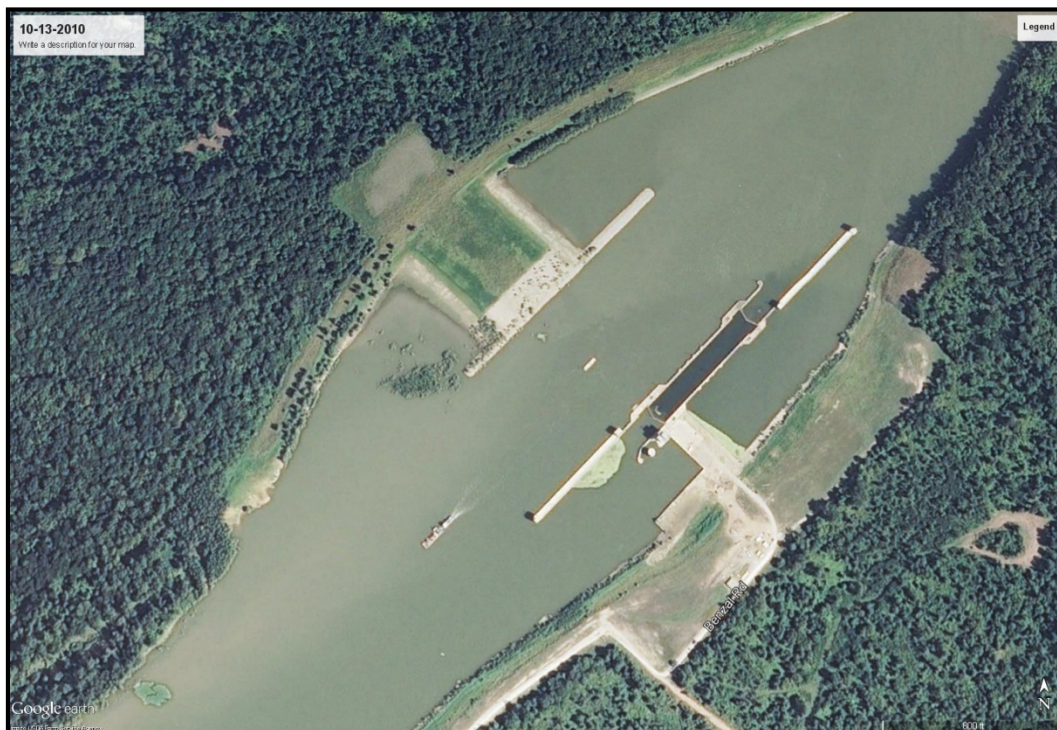
Figure 10. MPLD at higher water, 13 October 2010. Most of sediment accumulation upstream and downstream of earthen dam behind revetments is underwater (photo from Google Earth).

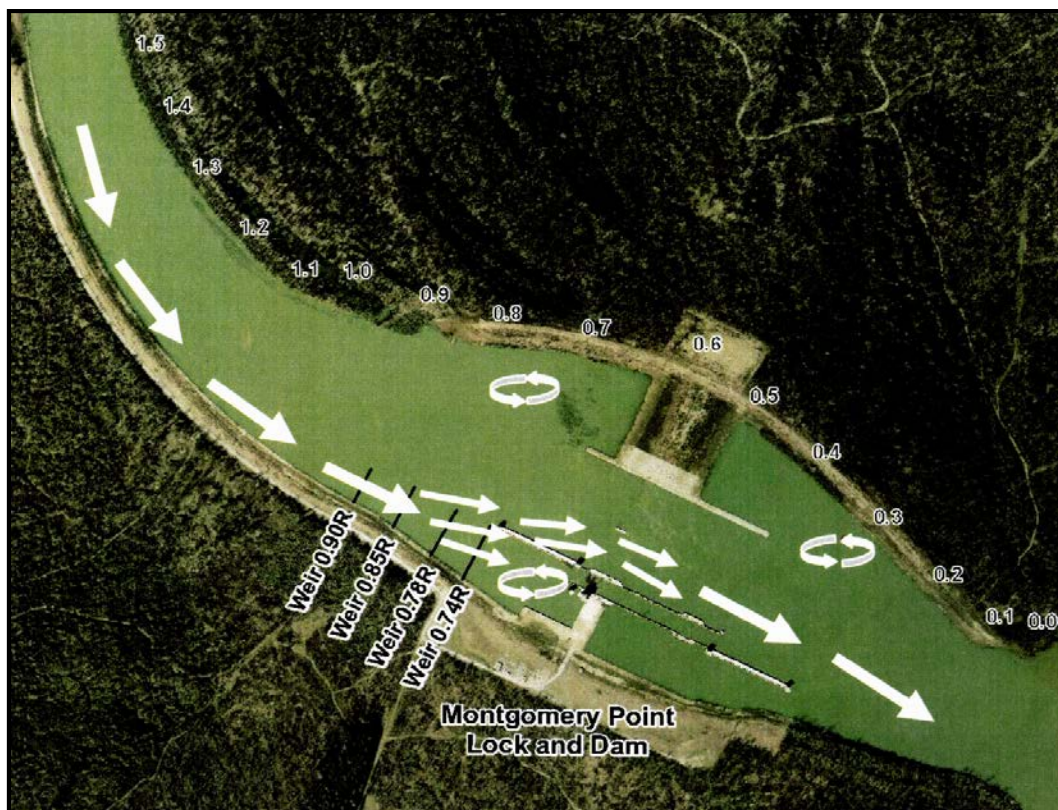
As a result of the new lock and dam, the previous navigation channel was shifted from the RDB north towards the center of the river between RMs 0.0 and 0.9 [Figure 15]. This relocation of the navigation channel created significant outdraft when there are moderate to high flows on the White River and the Mississippi River is falling (Cox et al. 2011).

Figure 15. General flow trends indicated by ERDC and SWL ADCP field velocity surveys, as interpreted by USACE AREC. (Graphic 1 of Cox et al. 2011; by permission).

It is apparent that the flow exiting the bend at RM 1.0 was only slightly influenced by the weirs and split near the floating [guide] walls. The weirs do not have much of an effect on the flow because they have minimal section (approximately 5 ft) and are at an angle perpendicular to the bank line and the lock and dam. Generally weirs are angled such that the end of the weir in the channel is upstream of the portion of the weir tied into the bankline. The upstream angled weirs disperse high velocities across its section and direct some flow towards the inside of the bend or channel (Cox et al. 2011).

Because most of the energy is directed towards the LDB, during high water tows are pulled toward the navigation pass pier. As a result of the split flow at the [guide] wall, an eddy forms near the RDB, [guide] wall, and miter gate. The flow directed towards the eddy is still strong enough to influence tows in that direction as well. During high water, flows rushing under the [guide] wall towards the LDB have been strong enough to slightly twist the floating [guide] wall. Overall, the flow just upstream of the lock has

been extremely difficult to predict, and as a result, conditions have been difficult to navigate (Cox et al. 2011).

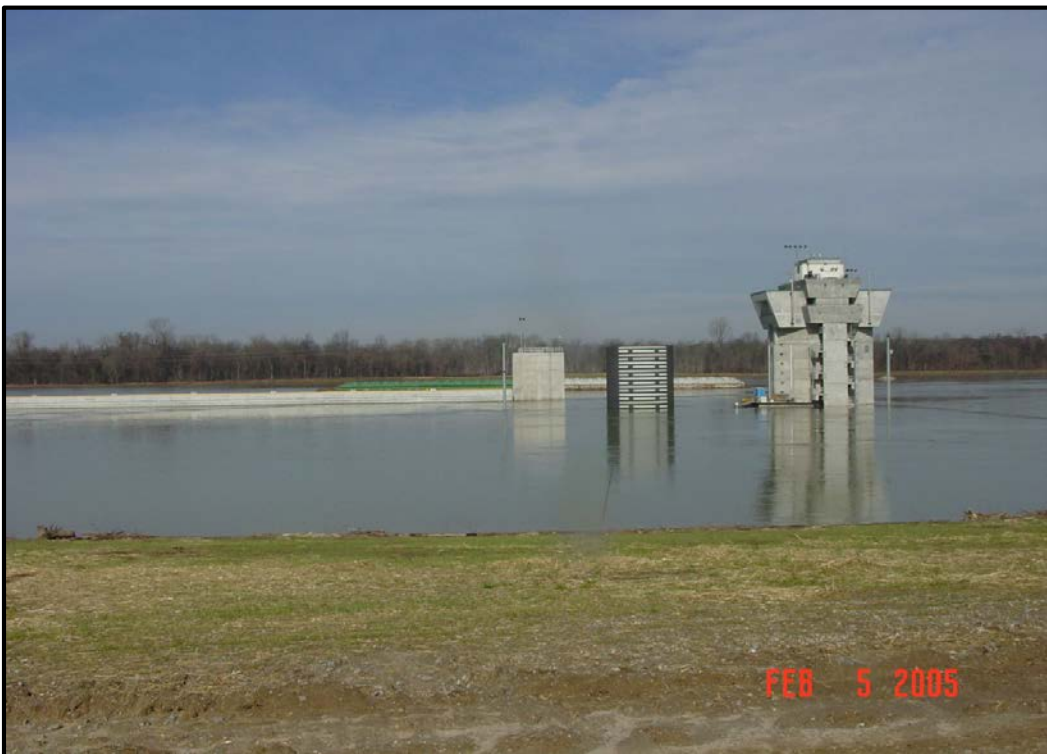
The entire MPLD complex is built below the White River bank line, except the control tower. At extreme high water on the Mississippi River, the entire MPLD complex will become submerged, except the control tower (Figure 20). The concrete navigation pass abutment pier (Figure 21) may then become a hazard to navigation. Figure 22 shows a tow boat sitting on top of the pier after an allision on 11 February 2005, shortly after MPLD was placed into service 24 August 2004. Since the opening of the lock, there have been at least five significant allisions.

Figure 20. At higher water, the entire MPLD complex becomes submerged, except for the control tower and the lock guide walls abutment piers.

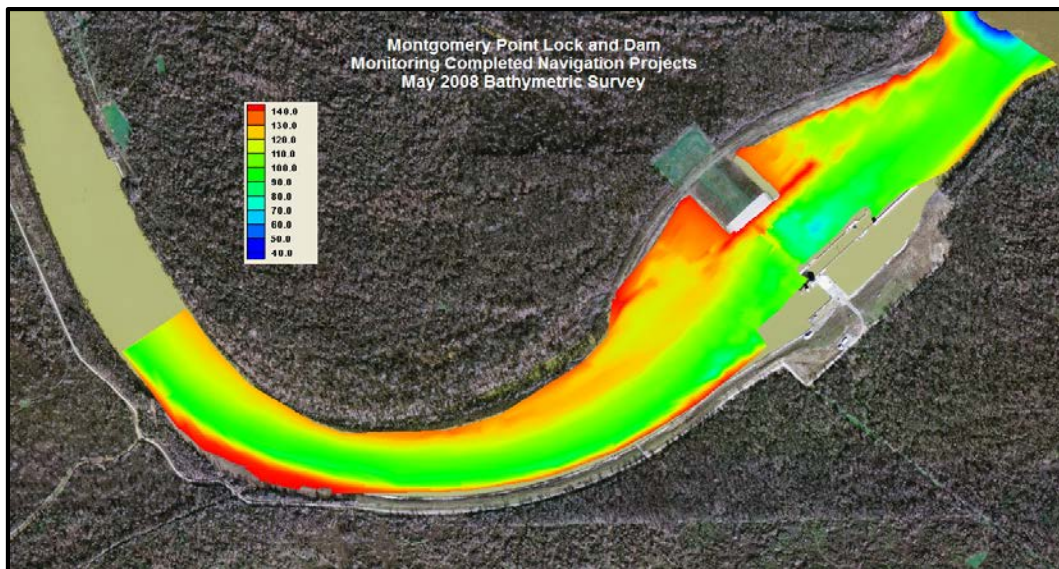
Bathymetric survey data were collected using a 200 Khz single beam echo sounder. The bathymetric surveys for May 2008 and June 2009 are shown in Figures 24 and 25, respectively. Figure 24 (May 2008 survey) shows a deeper area in the channel bathymetry just downstream of the stone protection of the navigable pass stone and north of the lock stone protection to about elevation 68 ft NGVD29 when compared to the surrounding area at elevation 75 to 80 ft NGVD29.

Figure 24. May 2008 bathymetric survey, White River, vicinity of MPLD, high water, pool elevation approximately 150 ft NGVD29. Scour hole bottom elevation approximately 68 ft NGVD29.

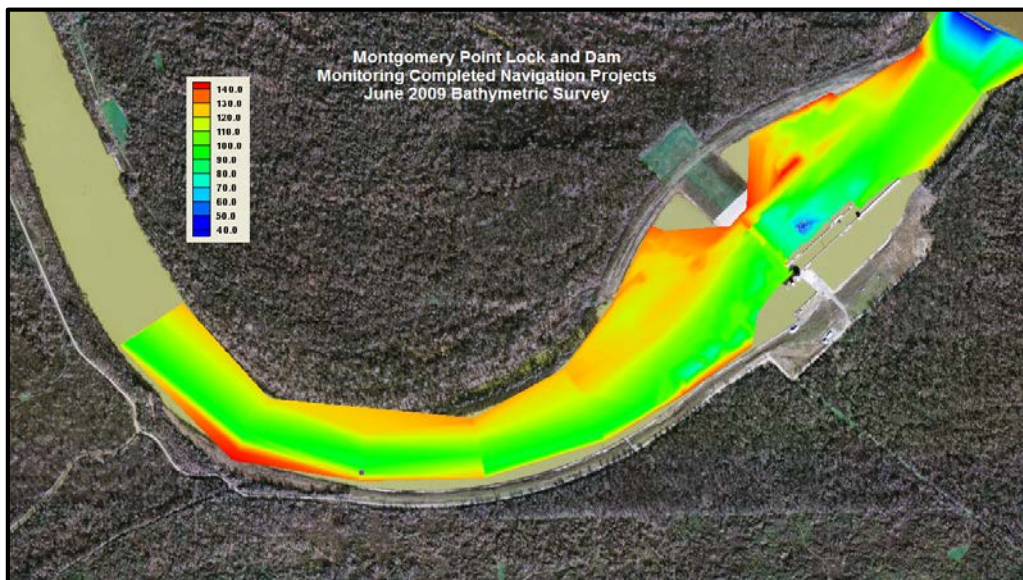
Figure 25. June 2009 bathymetric survey, White River, vicinity of MPLD, high water, pool elevation approximately 148 ft NGVD29. Scour hole bottom elevation approximately 45 ft NGVD29.

Figure 25 (June 2009 survey) shows additional deepening and widening in the area just downstream of the stone protection of the navigable pass stone and north of the lock stone protection to approximately elevation 45 ft NGVD29.

Himstedt (2015, personal communication) stated that dredged material had been placed in the scour hole in 2007 and covered with four work-barge loads of stone, although the stone size was not available. The difference map between the May 2008 and June 2009 surveys (Figure 28) showed significant degradation and widening of the area just downstream of the stone protection of the navigable-pass stone and north of the lock stone protection. This comparison showed approximately 23 ft of additional degradation in this area, with more degradation farther downstream along the lock. The scour hole appeared to have widened and lengthened quite significantly during this time period. The scour hole was approximately 115 ft wide and 260 ft long, according to the survey of June 2009.

The scour hole developed at this specific location because river flow at high water over the fixed-bed navigation pass is analogous to high-velocity turbulent flow over a weir. The resulting high-velocity currents provide forces capable of scouring the movable bed material comprising the river bottom in this vicinity. Based on these survey data showing significant scour hole enlargement between May 2008 and June 2009, it was recommended that SWL fill and stabilize the scour hole with stone sufficiently large enough to prevent scour hole enlargement with resulting potential endangerment of the navigation structures.

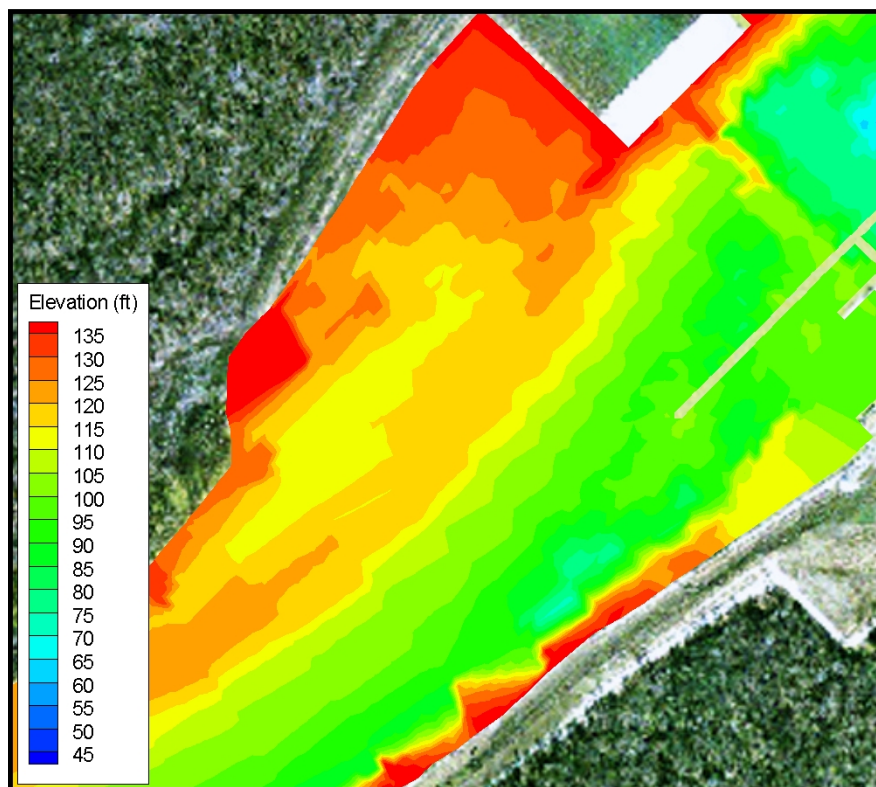
Figure 29. Close-up view of bathymetry of the MPLD upstream lock approach, May 2008.

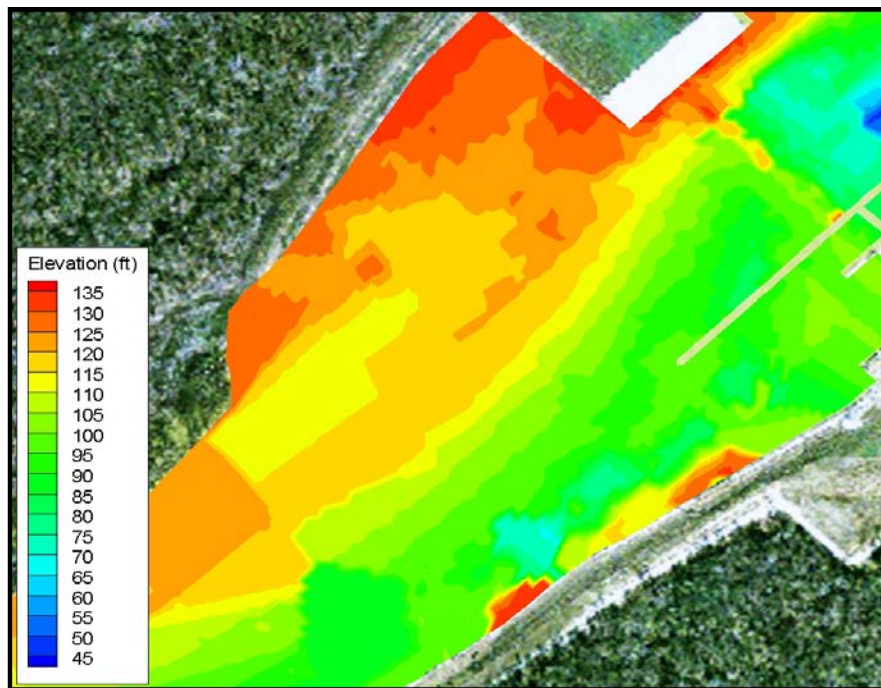
Figure 30. Close-up view of bathymetry of the upstream lock approach, June 2009.

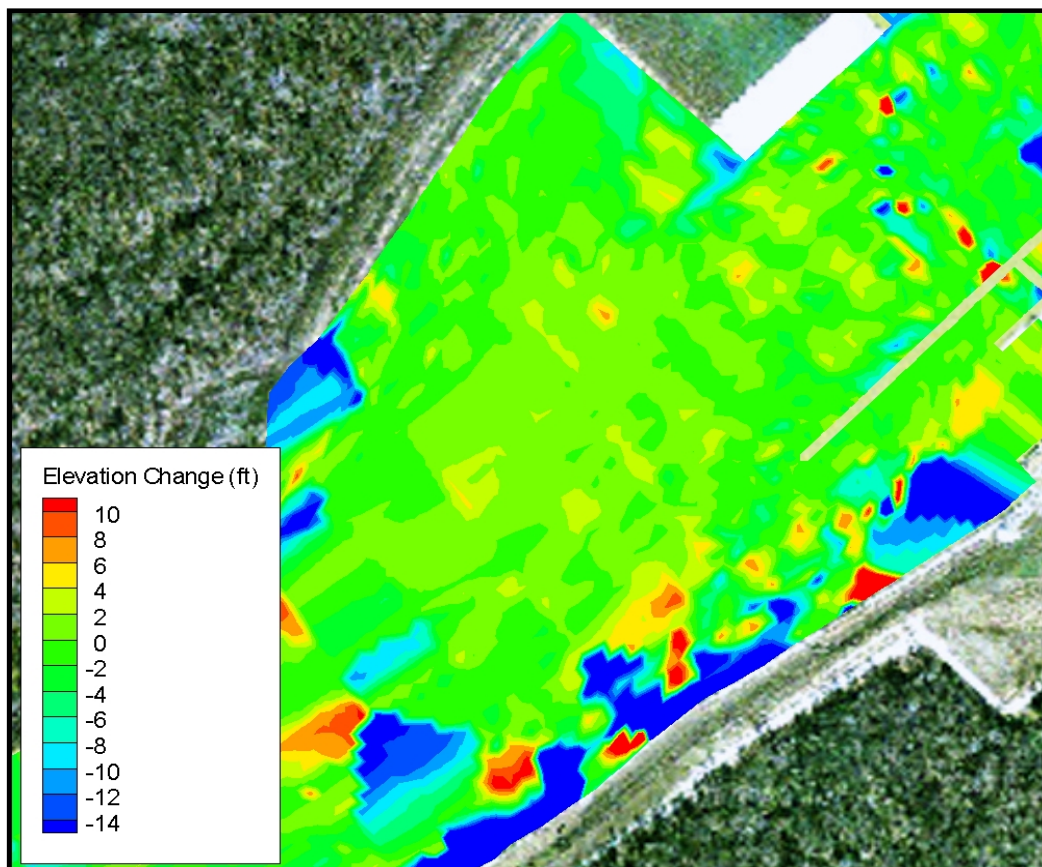
The differences in elevation between May 2008 and June 2009 at these upstream approaches to the lock and navigation pass were insufficient to impede barge traffic, being only approximately 4–6 ft in very small areas of that reach of the waterway (Figure 31). No maintenance channel dredging was required because these small sections of deposition would be easily obliterated by propeller wash.

Figure 31. Difference map showing change in upstream lock approach channel elevation between May 2008 and June 2009, vicinity of MPLD.

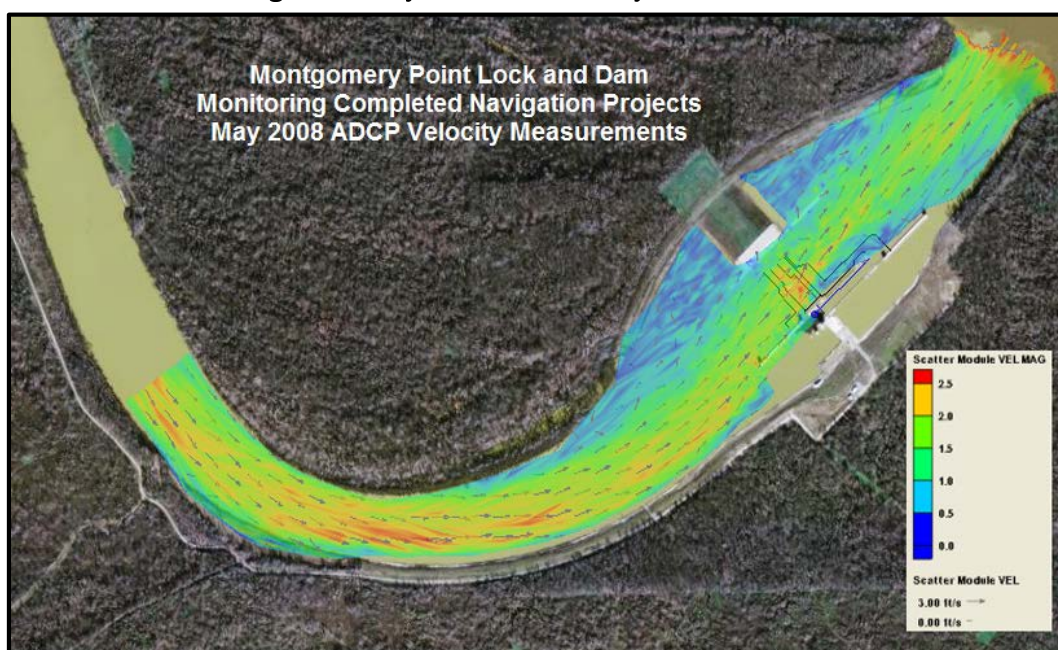
Figure 32. May 2008 ADCP velocity measurements.

The ADCP discharge measurement for the May 2008 survey was approximately 57,000 cfs at a water level approximately 148.0 ft NGVD29. Current magnitudes and direction data obtained from the ADCP data indicated that flow was concentrated along the RDB in the bend upstream of the lock and into the upper lock approach. Current magnitudes ranged from 2.0 to 2.5 fps in these areas. Once past the upper lock approach, the flow through the navigable pass tended to be concentrated toward the left end of the navigable pass in the vicinity of the pier separating the navigable pass and overflow weir. Large, slow-moving eddies with current magnitudes of 0.5 to 1.0 fps were observed upstream and downstream of the dam along the right bank.

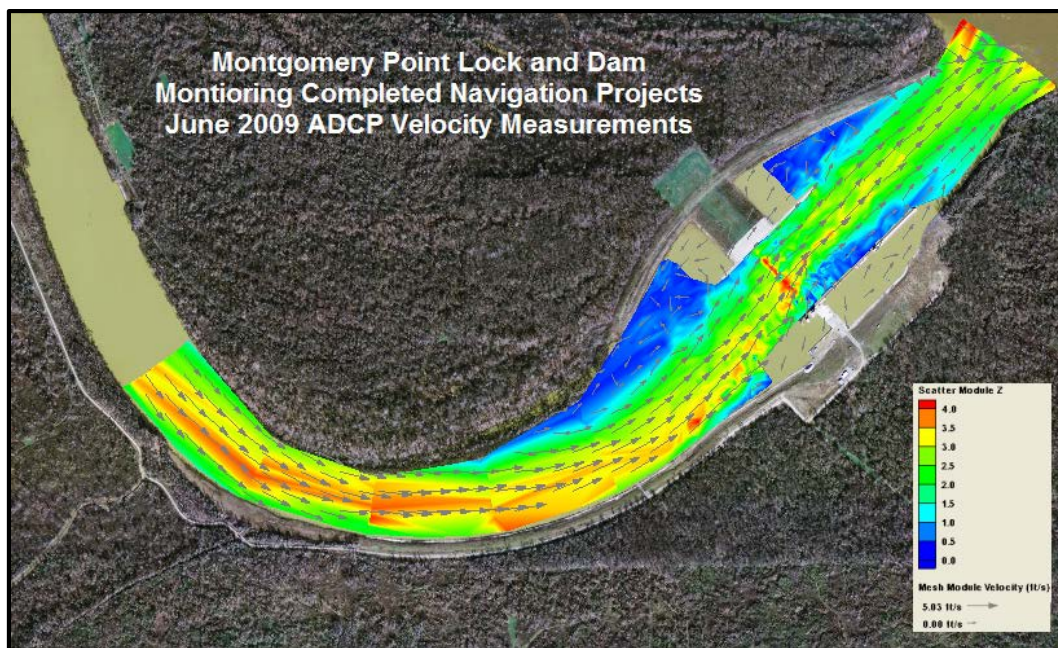
Figure 34. June 2009 ADCP velocity measurements.

The ADCP discharge measurement for the June 2009 survey was approximately 80,000 cfs and a water level approximately 148.0 ft NGVD29. Current magnitudes and direction data obtained from the ADCP data indicate the same trend as those observed in the May 2008 survey; however, current magnitudes were greater and ranged from 3.0 to 3.5 fps. This should be expected since the discharge was greater and the water level was the same. Current magnitudes through the navigable pass and the overflow weir were approximately 4.0 fps. Large, slow-moving eddies with current magnitudes of 0.5 to 1.0 fps were also observed upstream and downstream of the dam along the right bank.

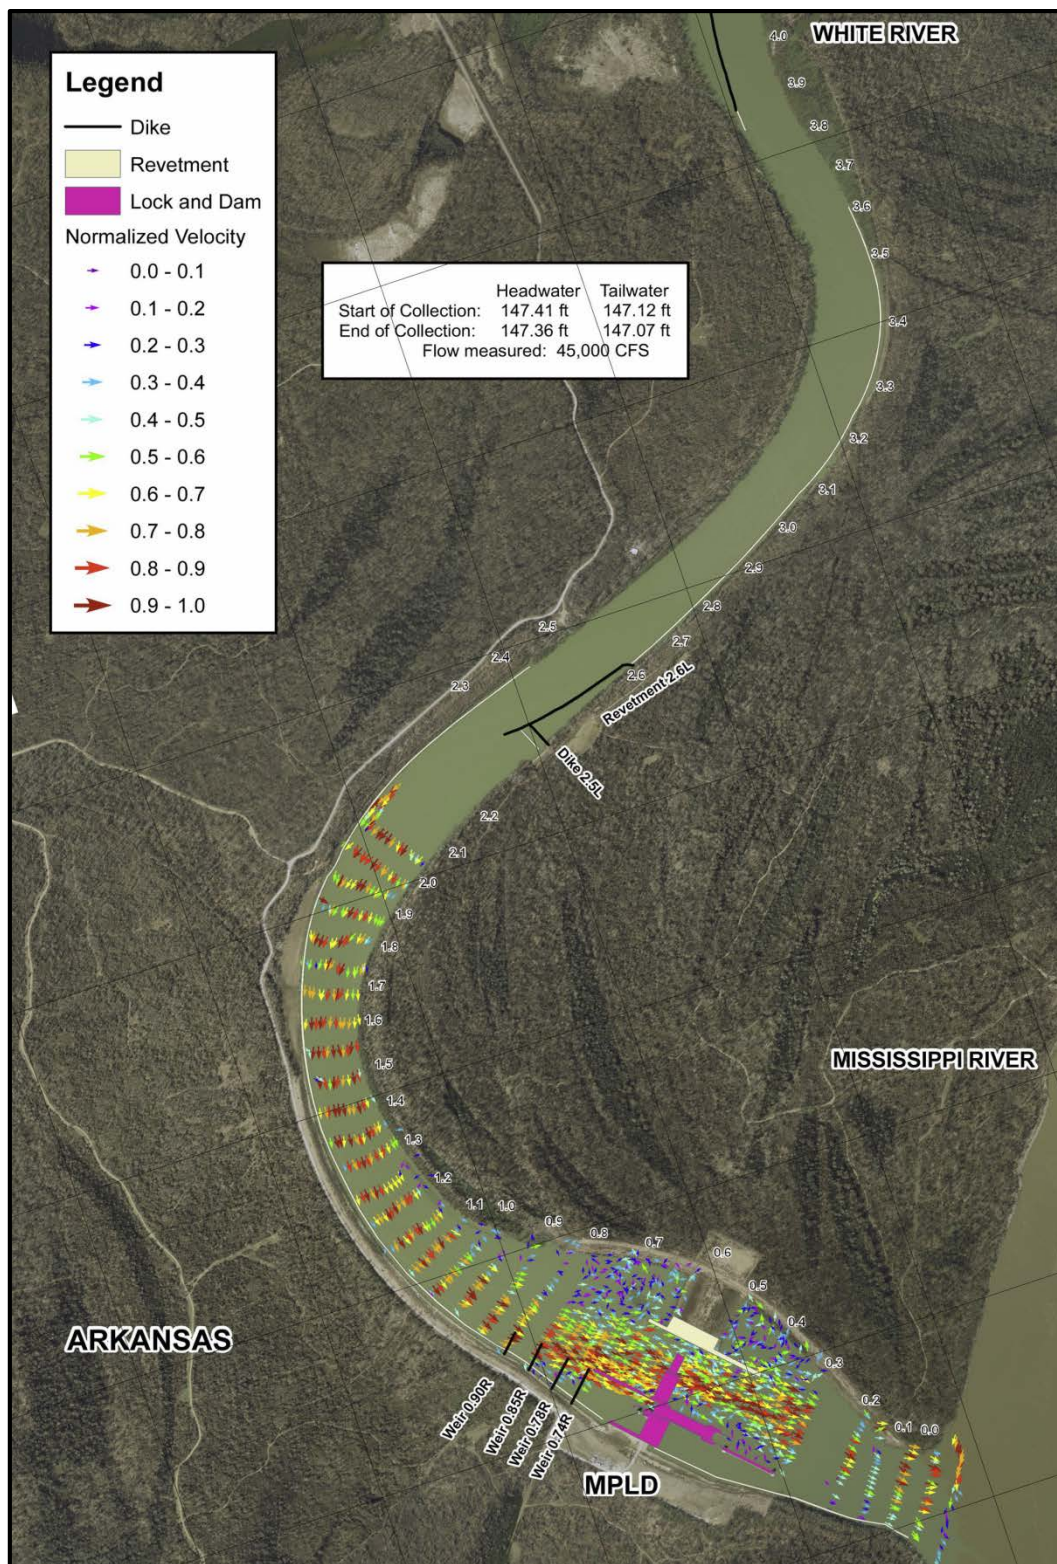
- “River Miles 4.0 – 3.7: The higher energy of the river was located near the RDB.”
- “River Miles 3.7 – 2.6: The highest velocities crossed to the LDB. Around RM 3.1, the highest velocities deflected off the LDB and stayed toward the middle of the channel.”
- “River Miles 2.6 – 2.2: The higher energy of the river was forced to the RDB by the kicker dike at RM 2.3.”

Figure 36. ERDC ADCP velocity data, May 2008. Normalized and interpreted by USACE AREC (Plate 23 of Cox et al. 2011; by permission).

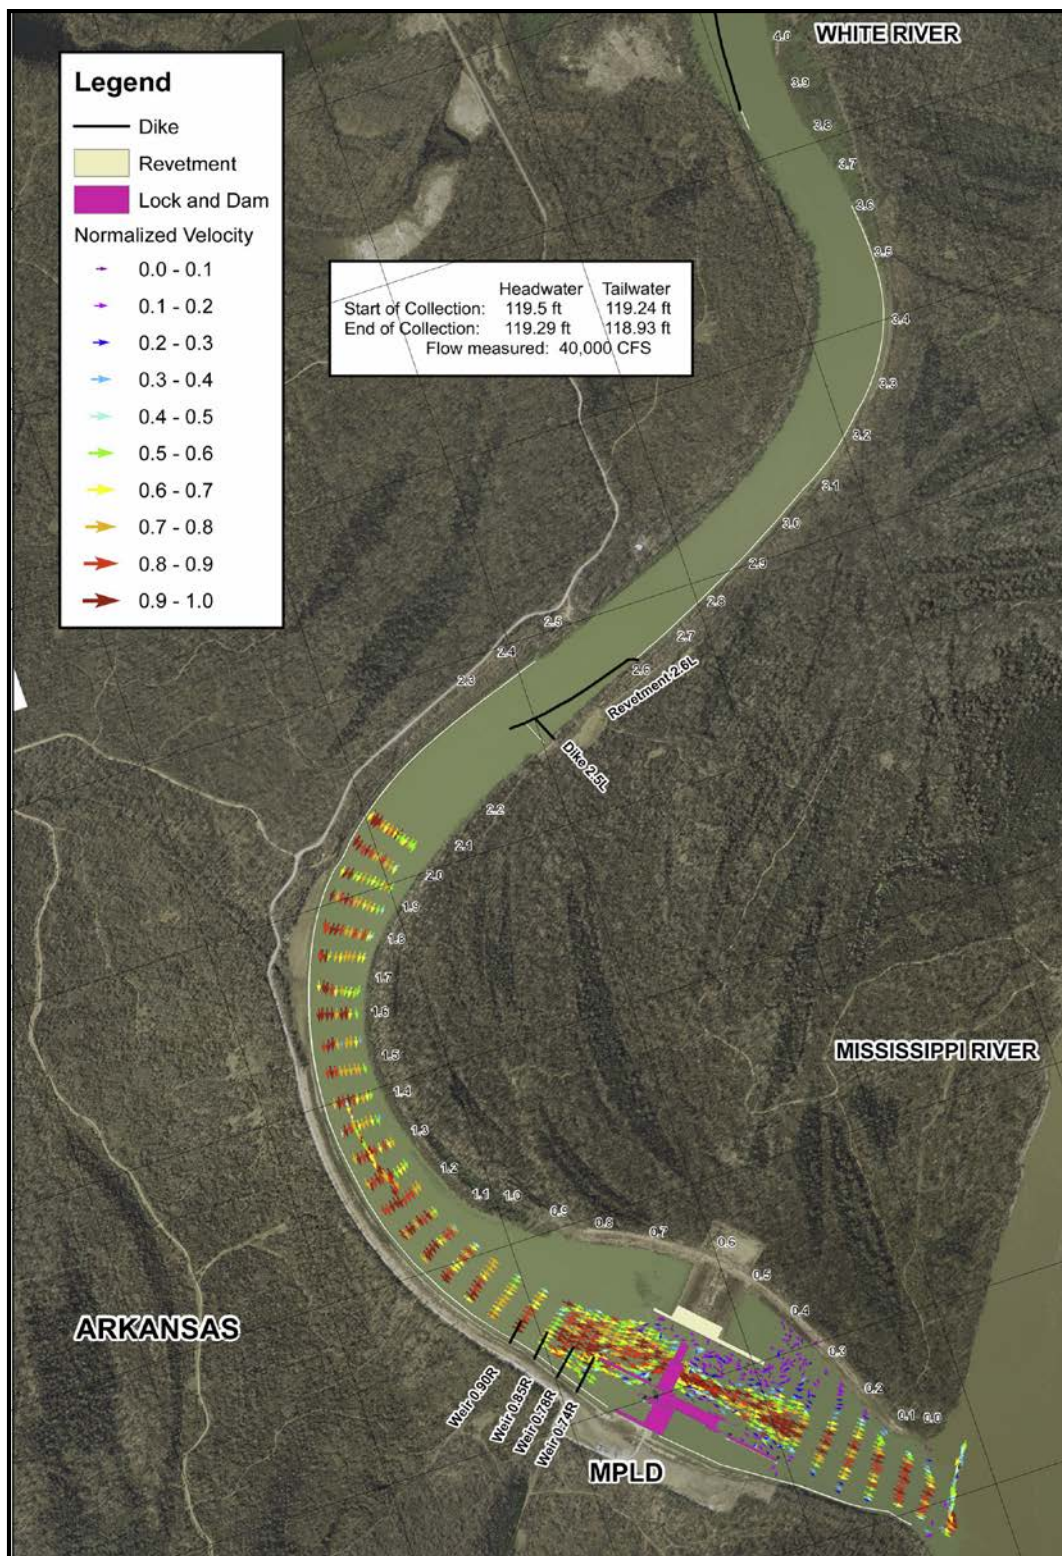
Figure 37. ERDC ADCP velocity data, September 2008. Normalized and interpreted by USACE AREC (Plate 24 of Cox et al. 2011; by permission).

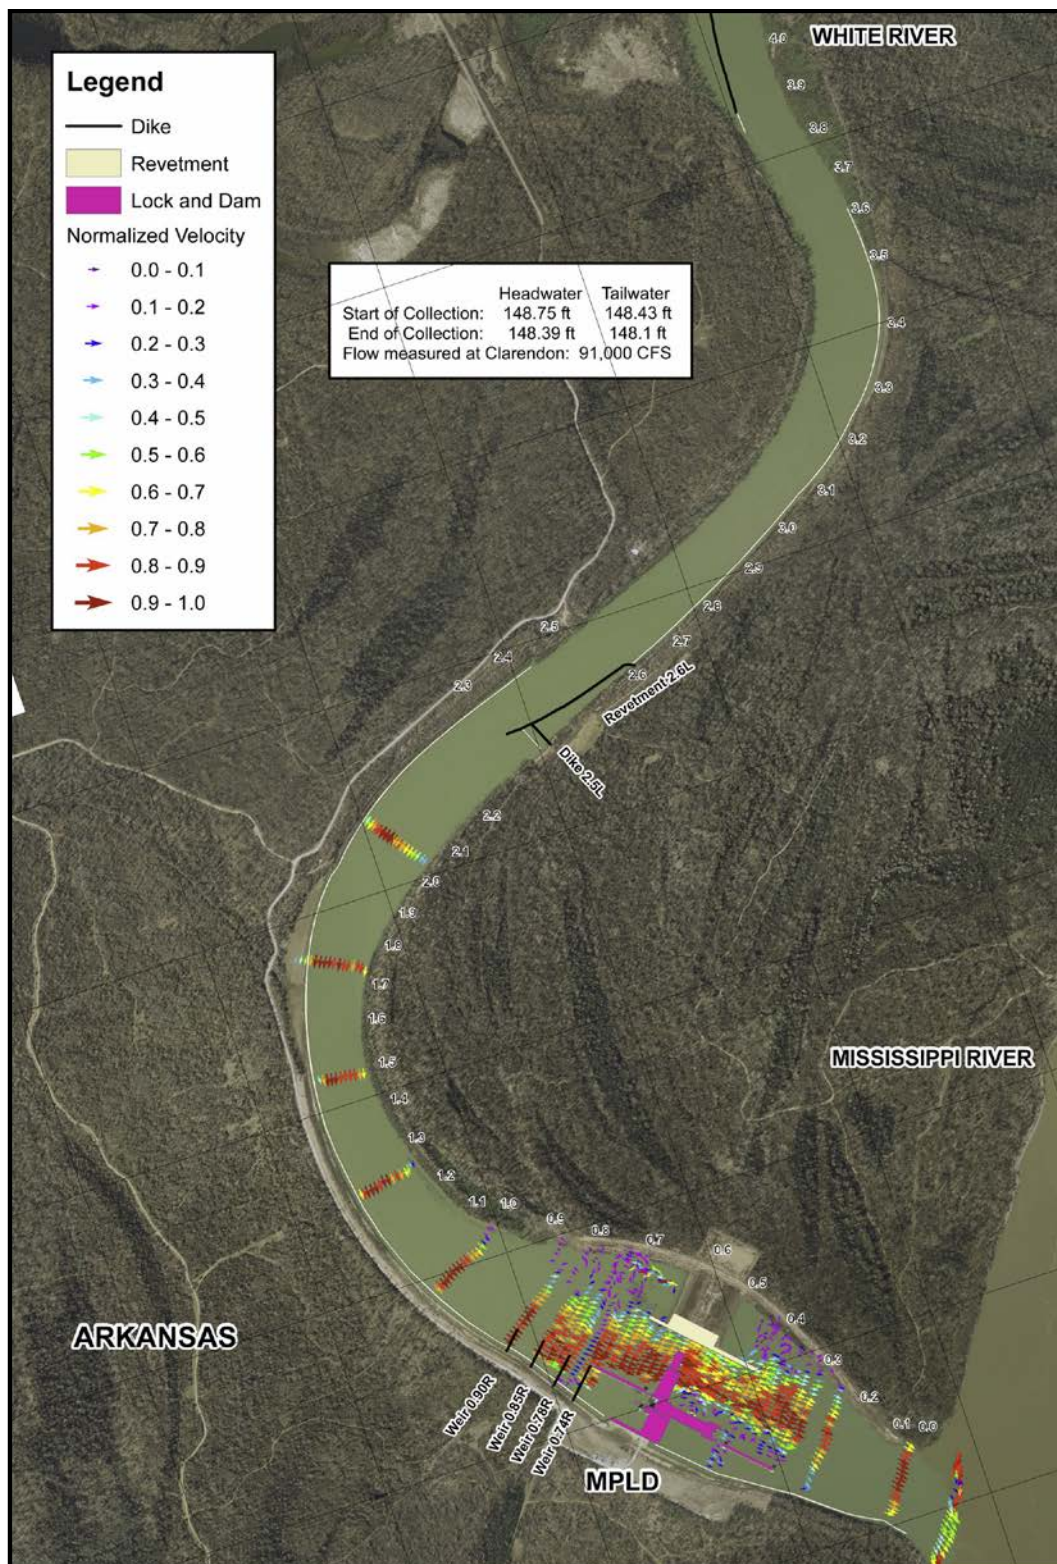
Figure 38. ERDC ADCP velocity data, June 2009. Normalized and interpreted by USACE AREC (Plate 25 of Cox et al. 2011; by permission).

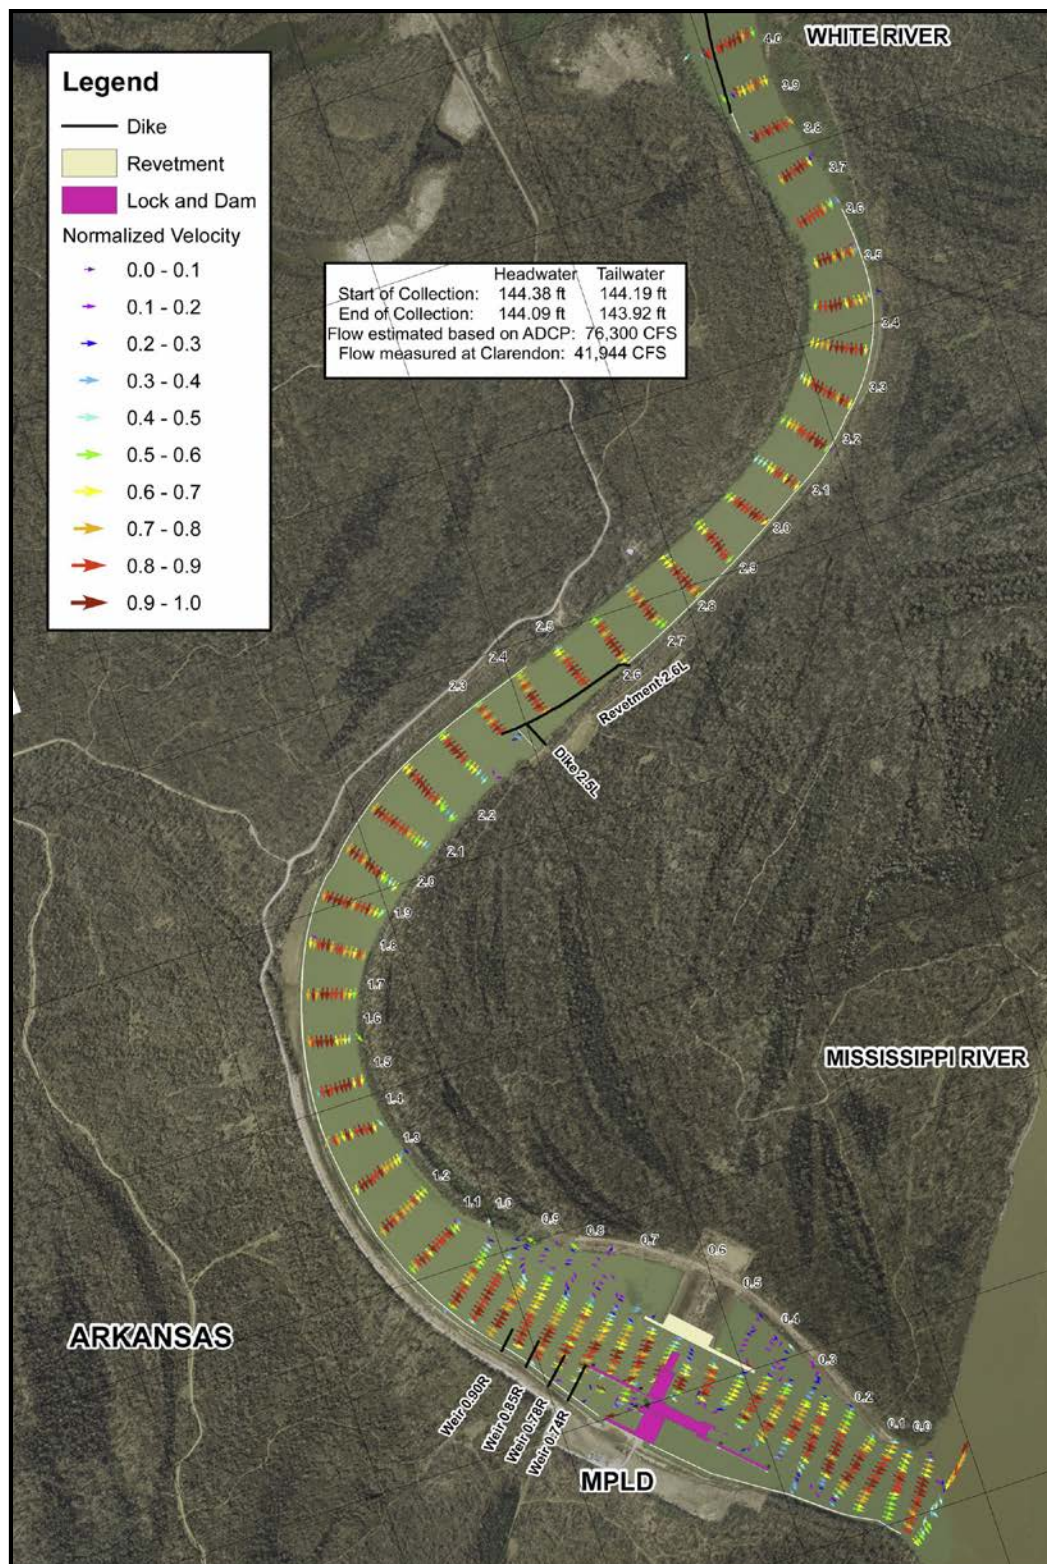
Figure 39. SWL ADCP velocity data, June 2010. Normalized and interpreted by USACE Applied River Engineering Center (Plate 26 of Cox et al. 2011; by permission).

- “River Miles 0.74 – 0.6: Slower velocities on the RDB created an eddy between the RDB, floating guide wall, and closed lock gate. Velocities also moved underneath the guide wall. The higher velocities were slightly angled towards the LDB, increased by the flows coming underneath the guide wall. At the navigation pass, high velocities were directed toward the navigation pass pier.”

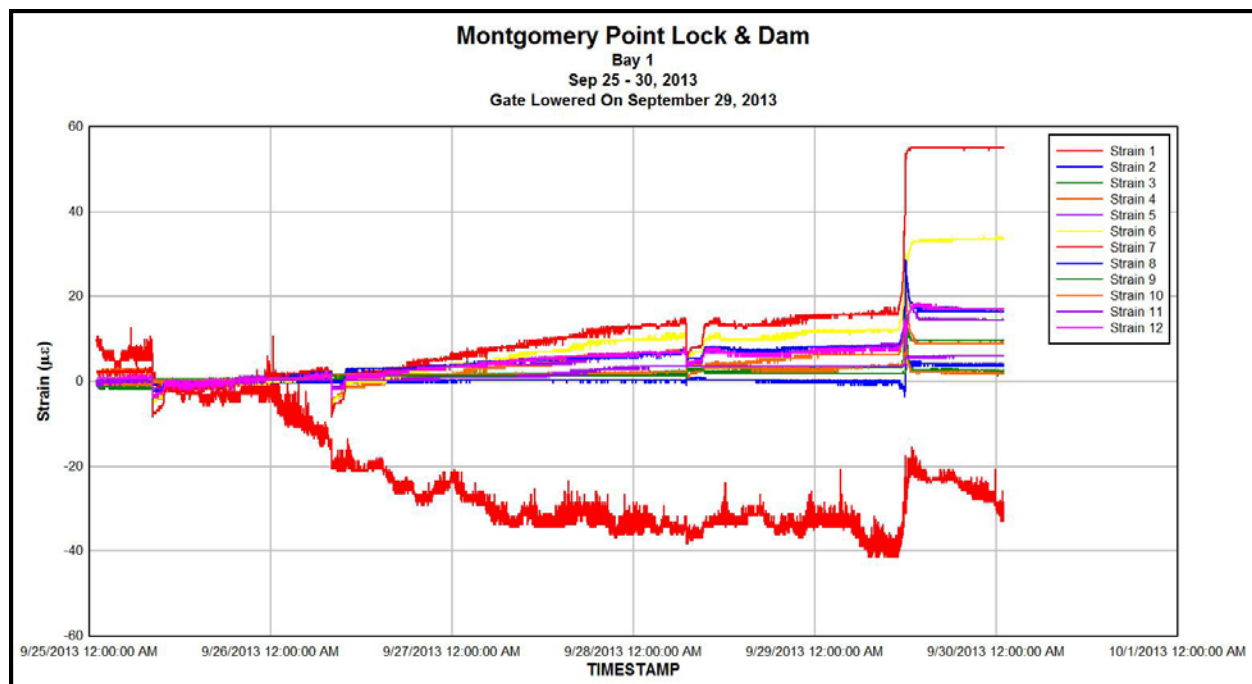
For the period of this gate load measurement investigation, the gates were (a) lowered on 29 September 2013, (b) raised on 1 October 2013, (c) lowered on 10 October 2013, (d) raised on 18 October 2013, and (e) lowered on 7 November 2013. Displays of the time histories of the strains (microstrain, $\mu\epsilon$) experienced by the gate strut mechanisms are shown in Figures 59 and 60 for Gate 1 (Bay 1) and Gate 4 (Bay 4), respectively, for gate lowering on 29 September 2013. Displays of the time histories of the strain, $\mu\epsilon$ (10^{-6} ft/ft), experienced by the gate strut mechanisms are shown in Figures 61 and 62 for Gate 1 (Bay 1) and Gate 4 (Bay 4), respectively, for gate raising on 1 October 2013. Here can be seen that the strains were exceedingly low for all conditions during lowering and raising of these gates (on the order of $\pm 50 \mu\epsilon$). No adverse situations occurred during any of these MCNP investigations. Strains in excess of $1000 \mu\epsilon$ would be required before serious concerns are raised.

This prototype monitoring study by the USACE MCNP program confirmed the findings from the previous physical model study by de Bejar (1995) that serious flow-induced vibrations in the MPLD hinged, torque-tube crest gates do not occur during either raising or lowering the gates.

Figure 59. Time history of strain experienced by Gate 1 (Bay 1), gate lowering on 29 September 2013.

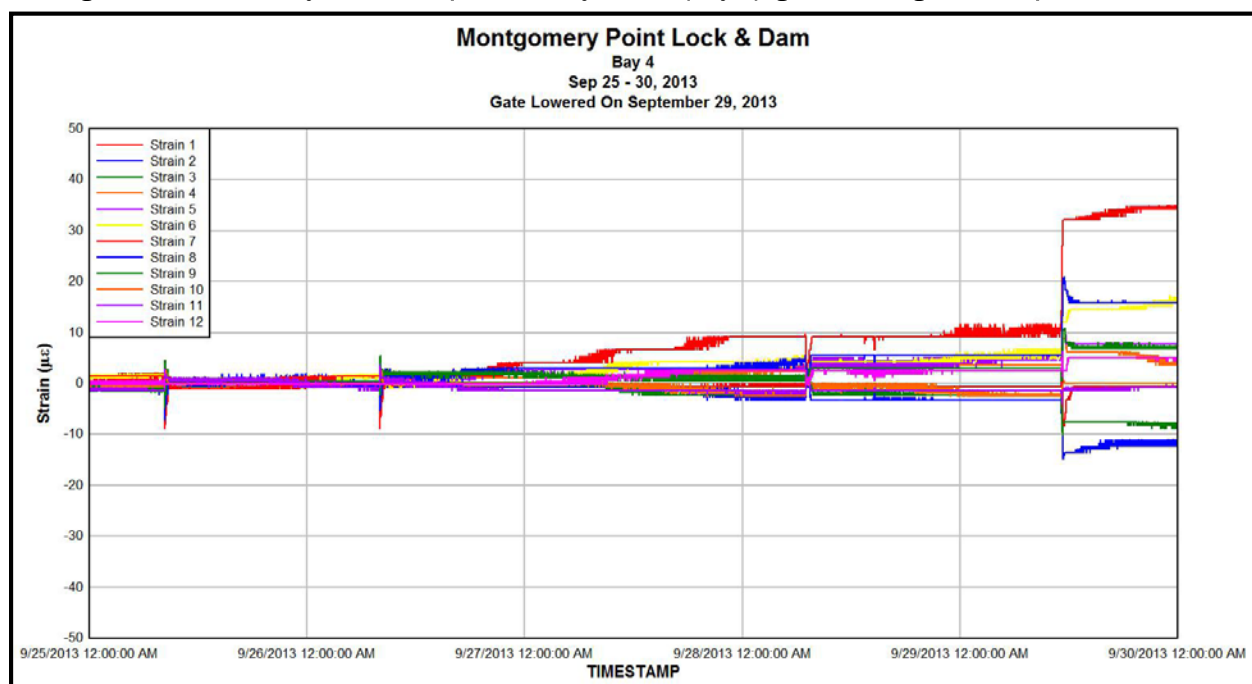
Figure 60. Time history of strain experienced by Gate 4 (Bay 4), gate lowering on 29 September 2013.

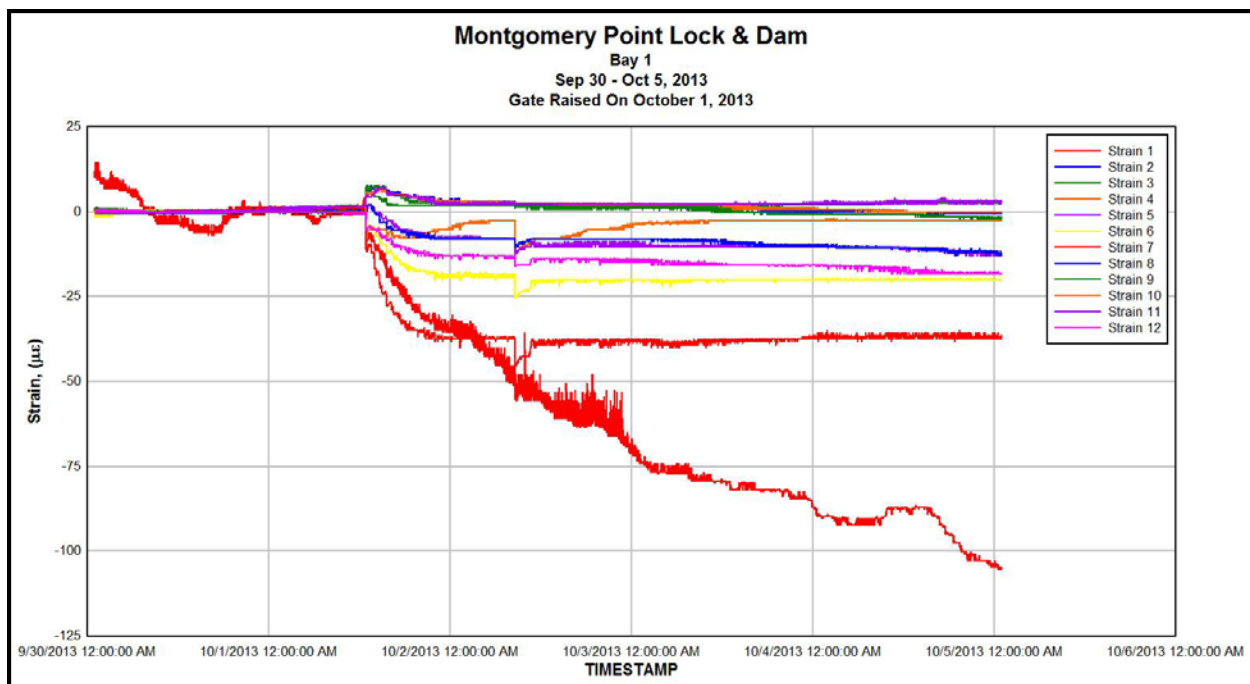
Figure 61. Time history of strain experienced by Gate 1 (Bay 1), gate raising on 1 October 2013.

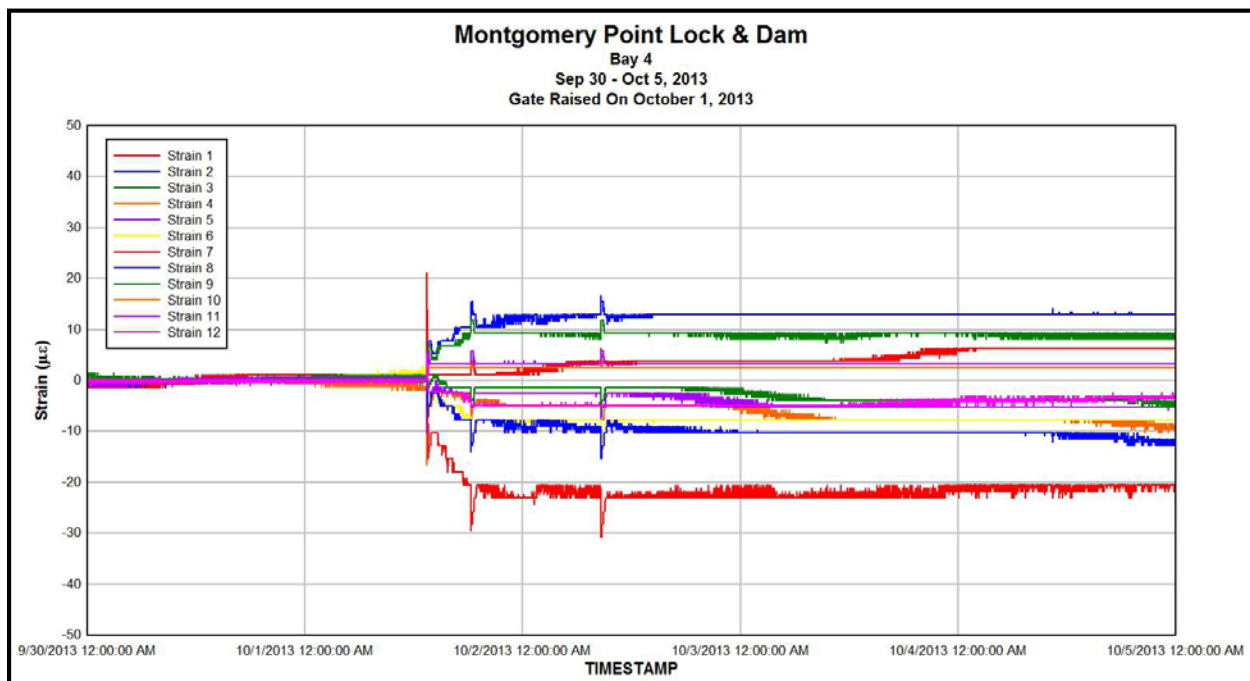
Figure 62. Time history of strain experienced by Gate 4 (Bay 4), gate raising on 1 October 2013.
